**Pioneer Rocketry
2019 WSGC Collegiate Rocketry Competition**

Elizabeth Bohlman, Jane Dickler, Morgan Fenger, Derek Kozak, Brennan Lawrence, Jaqueline Muller, Adam Nielsen, Ben Van Oss, Brendan Wayne
Pioneer Rocketry: University of Wisconsin-Platteville

Rocket Operation Assessment

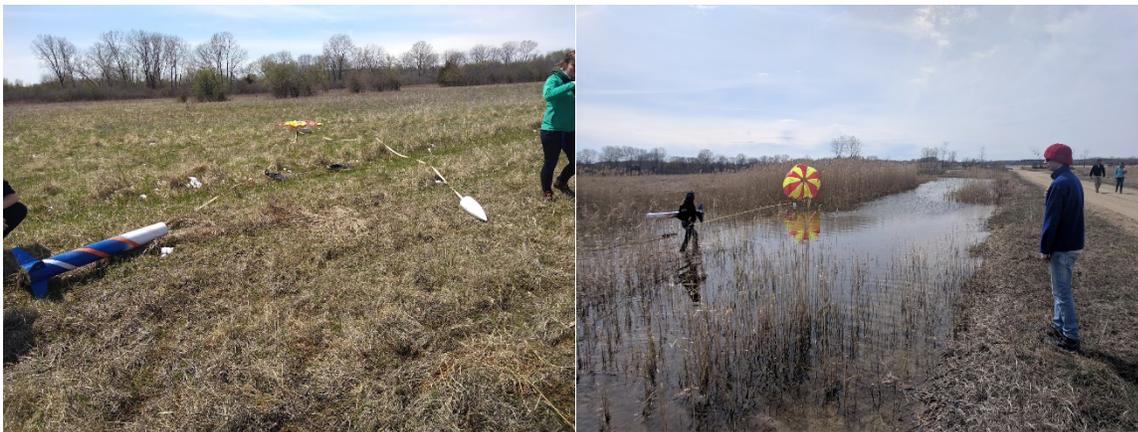
Rocket location and recovery analysis Locating the rocket posed no difficulty, as the team saw the rocket land nearby each time. Recovery after the first flight was without incident. Recovery after the second flight involved removing the rocket and GEM from a pond. Both flight landings are shown in Fig. 3. The rocket suffered no structural damage from the water. The GEM suffered some minor deformation that did not materially affect its performance. Upon investigation, the deformation occurred when the GEM was pulled forcefully from the pond via the shock cord. The GEM disconnected itself from the shock cord, the wheels began to spin, showing the electronics were fully working when it was removed from the pond.

Fig. 3: (Left) The rocket after the first flight. (Right) The rocket after the second flight.

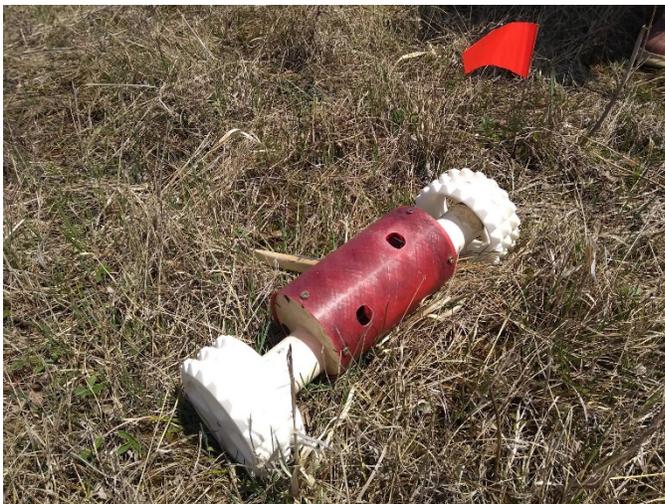
Distance traveled by GEM After the first flight, the GEM successfully detached itself from the shock cord. The rocket was no longer located near the GEM because the winds re-inflated the parachute and dragged the rocket away. Due to some programming problems, the wheels only moved for two seconds every two minutes resulting in the GEM moving 1 in. After the first flight the team troubleshooted the bugs in the program. During the second flight the rocket and GEM landed in water. The team picked up the GEM and rocket out of the water as soon as they landed to salvage as many materials as possible. Once out of the water, the GEM still detached from the shock cord and began moving. No distance was recorded due to the handling of the rocket and GEM.

Description of quality of motion on the ground Testing of the GEM's movement was done before flights on the terrain of Richard Bong State Recreation Area. The GEM was able to easily traverse both the rough grassy terrain and the gravel parking area without the flight program. Since there were issues in the flight program, the GEM only moved an inch after the first flight shown in Fig. 4. After the second flight, the GEM landed in water, so its ability to move well was not able to be demonstrated.

Fig. 4: GEM movement from the marker.

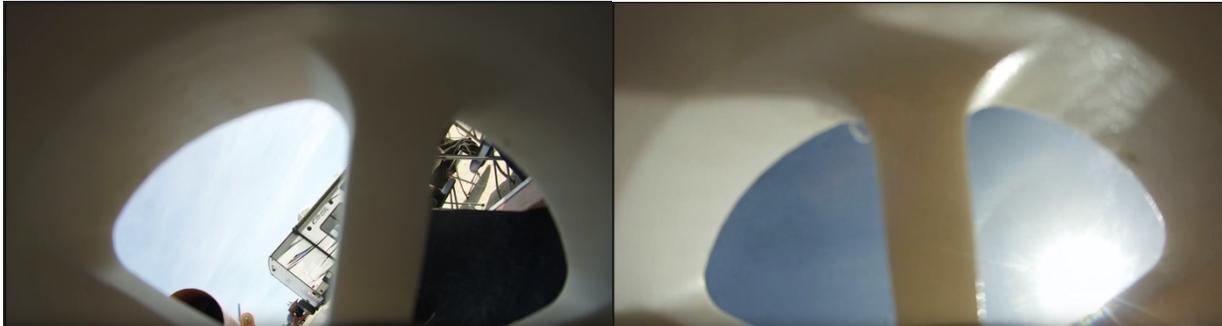
Discussion of overall payload performance and possible improvements The overall performance of the GEM was affected by a bugged program and damaged cameras. The program could have had a better plan, a simpler design, and more time writing and debugging. While nothing could have been done to prevent the landing in water, the GEM could have been made to also be buoyant and maneuver in water. Due to design choices there was no simple way to accomplish water resistance. The internal GEM camera could not record longer than 3 minutes at a time, resulting in no video of the first deployment. To resolve the recording issue, two cameras were added to the wheels of the GEM as shown in Fig. 5. These cameras were not properly charged and died before launch. For accurate recordings, well charged, working cameras should be used.

Fig. 5: View from the GEM cameras before the second flight.

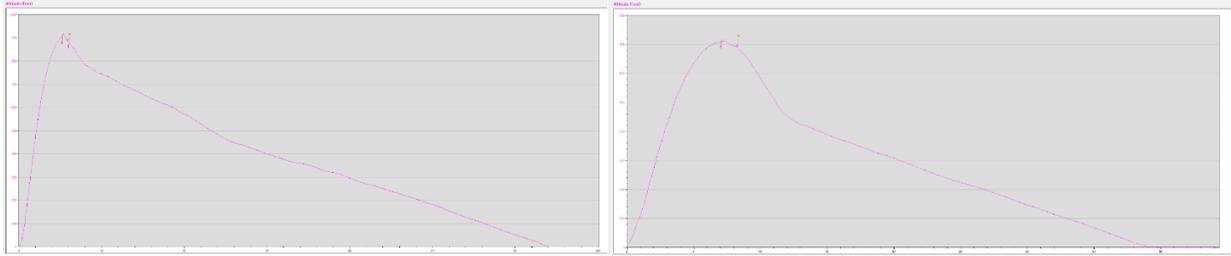
Propulsion system and flight path assessment The rocket safely and successfully performed two launches on the competition launch day. The apogees for the two flights were 896 ft and 742 ft and were quite different due to internal modifications between flights. The rocket flew vertically on both flights, with no weathercocking observed. Each motor ignited perfectly with no chuffing or any other anomalies shown in Fig. 1. Upon further observation, the rocket exceeded the altitude expectations during the first flight due to the data collected from an underperforming motor on a prior test flight. This data was used to predict the competition altitude which was much lower than the true performance of the motor. The team had anticipated this possibility and utilized a modular weight system to reduce the apogee on the second flight. As a result of the weight system, the flight reached 742 ft, an 8 ft difference from the predicted altitude.

Fig. 7: Altitude vs time data from the StratoLogger on the first (left) and second (right) flight, showing an altitude of 896 ft and 742 ft respectively.

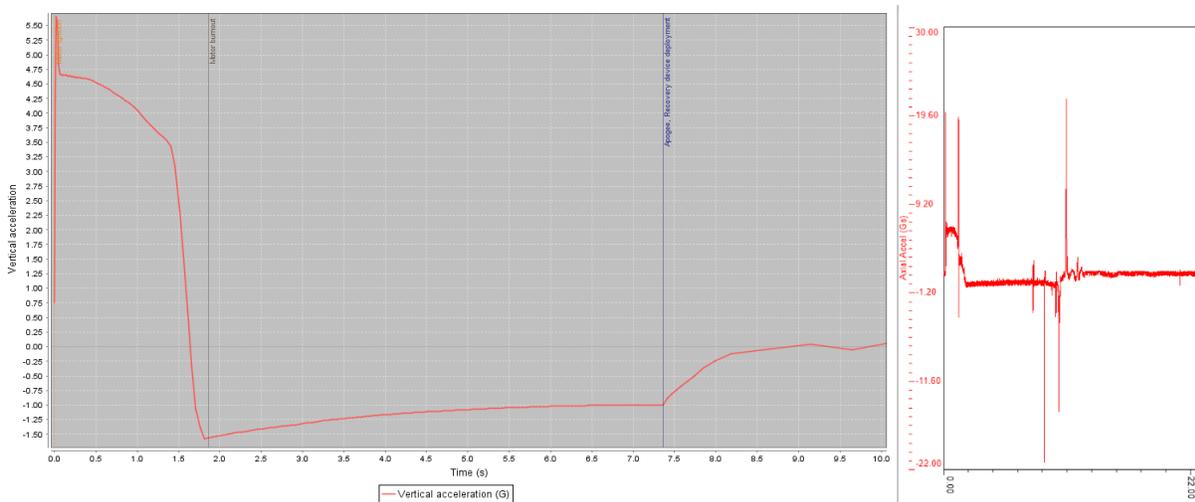
Acceleration comparison The team accurately modeled the acceleration vs time curve for the flight, as seen in Fig. 8. Unfortunately, due to landing in water on the second flight, acceleration data could not be retrieved from the Raven altimeter.

Fig. 8: Acceleration vs time simulation (left) and Raven data (right), showing a predicted maximum acceleration of 5.65 G, and an observed maximum sustained acceleration of 6.3 G.
