LAKE MICHIGAN LAUNCHERS
CARTHAGE COLLEGE

Lake Michigan Launchers Black Brant II

Carthage College Physics Department

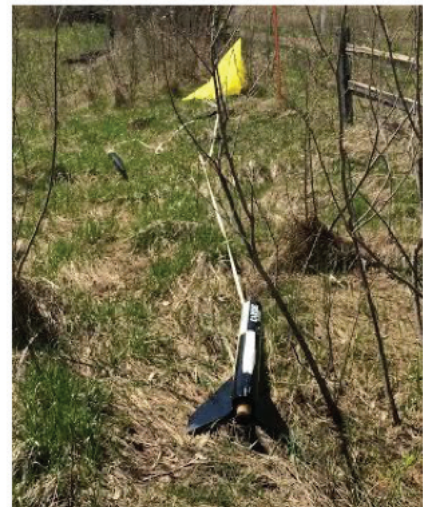
Fig. 1: Shows the Black Brant II post-launch position

The rocket was located approximately 1,300 feet away from the launch pad (approximated using Google Earth). This distance was much less than expected due to the deployment of the main parachute at apogee. It was found behind a group of trees and bushes laying on its side as shown. The rocket was thoroughly inspected by a Tripoli member as well as the team. Two of the three fins are slightly pliable and that was the only part of the rocket that was minorly damaged during flight. Our electronics were periodically beeping, not as expected, so there were initial concerns. Later, there were not any issues pertaining to a failure of the electronics.

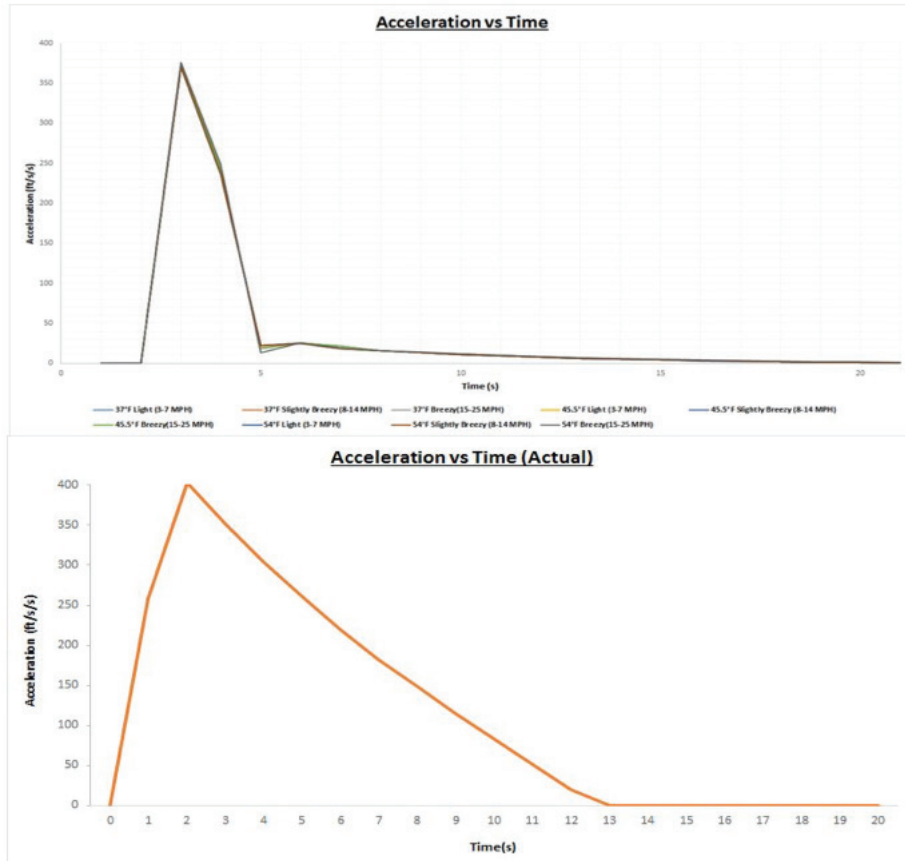
The top chart displays our predicted acceleration curve while the bottom chart demonstrates the actual acceleration curve. The actual acceleration curve was greater than our predicted curve.

Graph 2 demonstrates the acceleration of flight over time. The top graph shows the predicted acceleration at different wind speeds. The bottom graph shows the actual acceleration taken by the altimeter.

Predicted	Actual
Altitude (ft)	2726	2279
Max Acceleration (ft/s/s)	479.35	400

Our predicted altitude differed from our actual by 447 ft and the max acceleration differed by 79.35 ft/s².
