**Pioneer Rocketry**  
**2021 WSGC Collegiate Rocketry Competition**  
Zach Geier, Erin Kammann, Brian Lee, Ben Van Oss  
Pioneer Rocketry: University of Wisconsin-Platteville

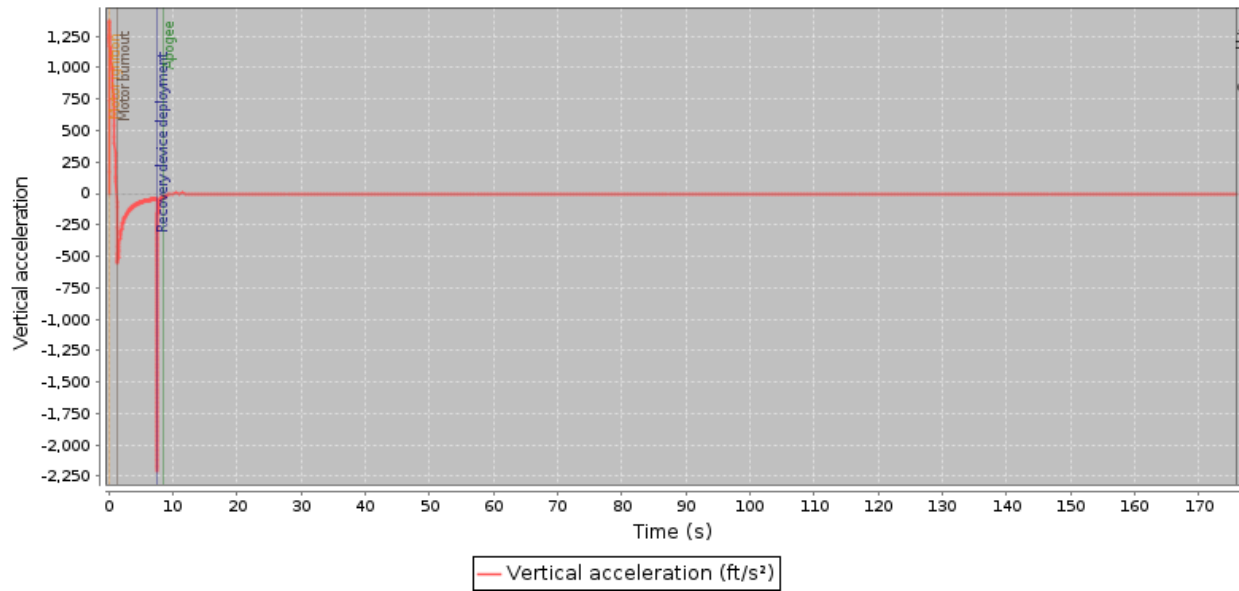
Figure 2: Predicted acceleration, showing a maximum of 1250 ft/s<sup>2</sup>

The acceleration was to be calculated using the GPS, Raspberry Pi, and StratoLoggerCF. Actual flight acceleration was not recorded due to the loss of power.

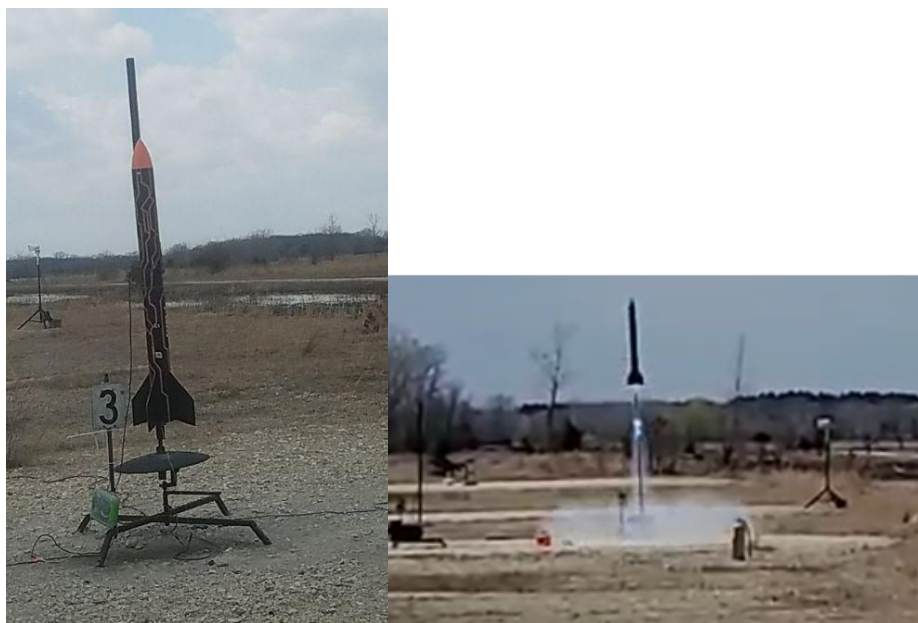
Figure 3: “Error :(“ on the rail (left) and taking off (right) during the competition flight.
